THESIS

FATIGUE MONITORING OF 70-30 COPPER-NICKEL

Franklin Bruce Lash

June 1970

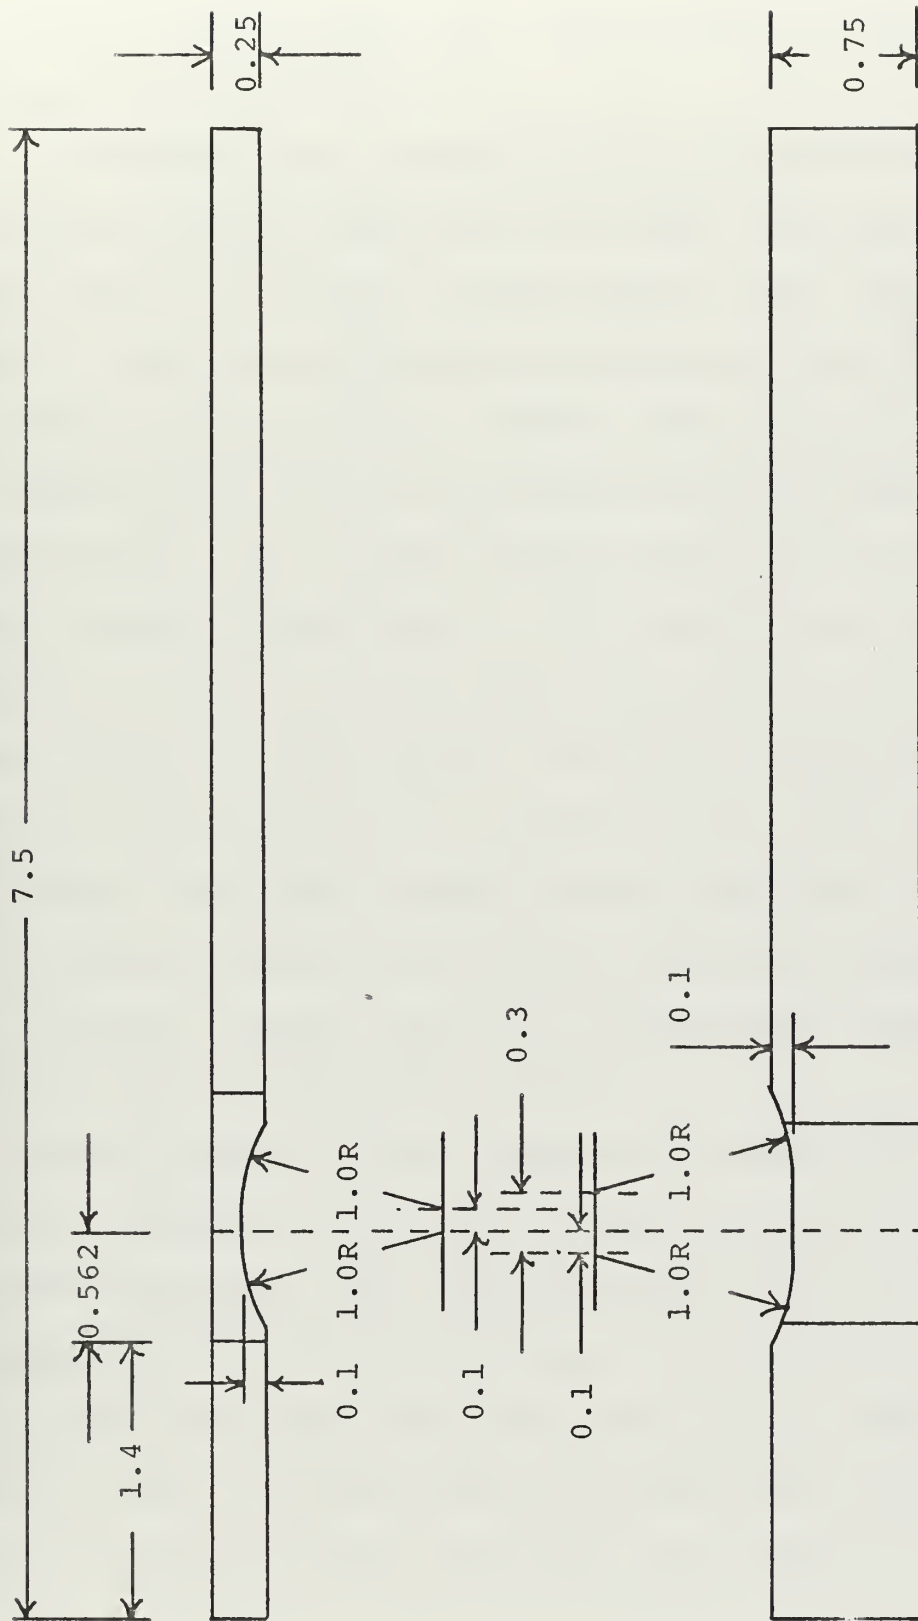
Figure 1. S/N Fatigue Specimen, Type 1

Initial tests in this study verified the results obtained by Rowe. However, at low strain levels it was observed that the resistance change at crack initiation was much lower than was anticipated. During these tests a question as to the suitability of the fatigue specimen being used was raised. The initial tests were conducted using the S/N fatigue specimen designed by Mr. W. T. Bean. (We will refer to this specimen as Type 1) (Figure 1). These tests were numbers 1A through 5A inclusive and 1 through 7. Tests number 8 through 11 were performed on a specimen of the same configuration (Type 1) but lengthened to ten inches. This was done to allow testing at lower strain levels. The cracks in specimen Type 1 at the low strain levels initiated on the bottom surface and propagated upward. These cracks started at the juncture of the curved and flat section. It was decided that these results

were due to the existence of a stress raiser on the bottom surface at those points.

At this time it was determined that the original specimen, type 1, had a stress raiser that made the lower surface the preferred area to crack. To eliminate this as much as possible, specimen type 3 was used for following tests.

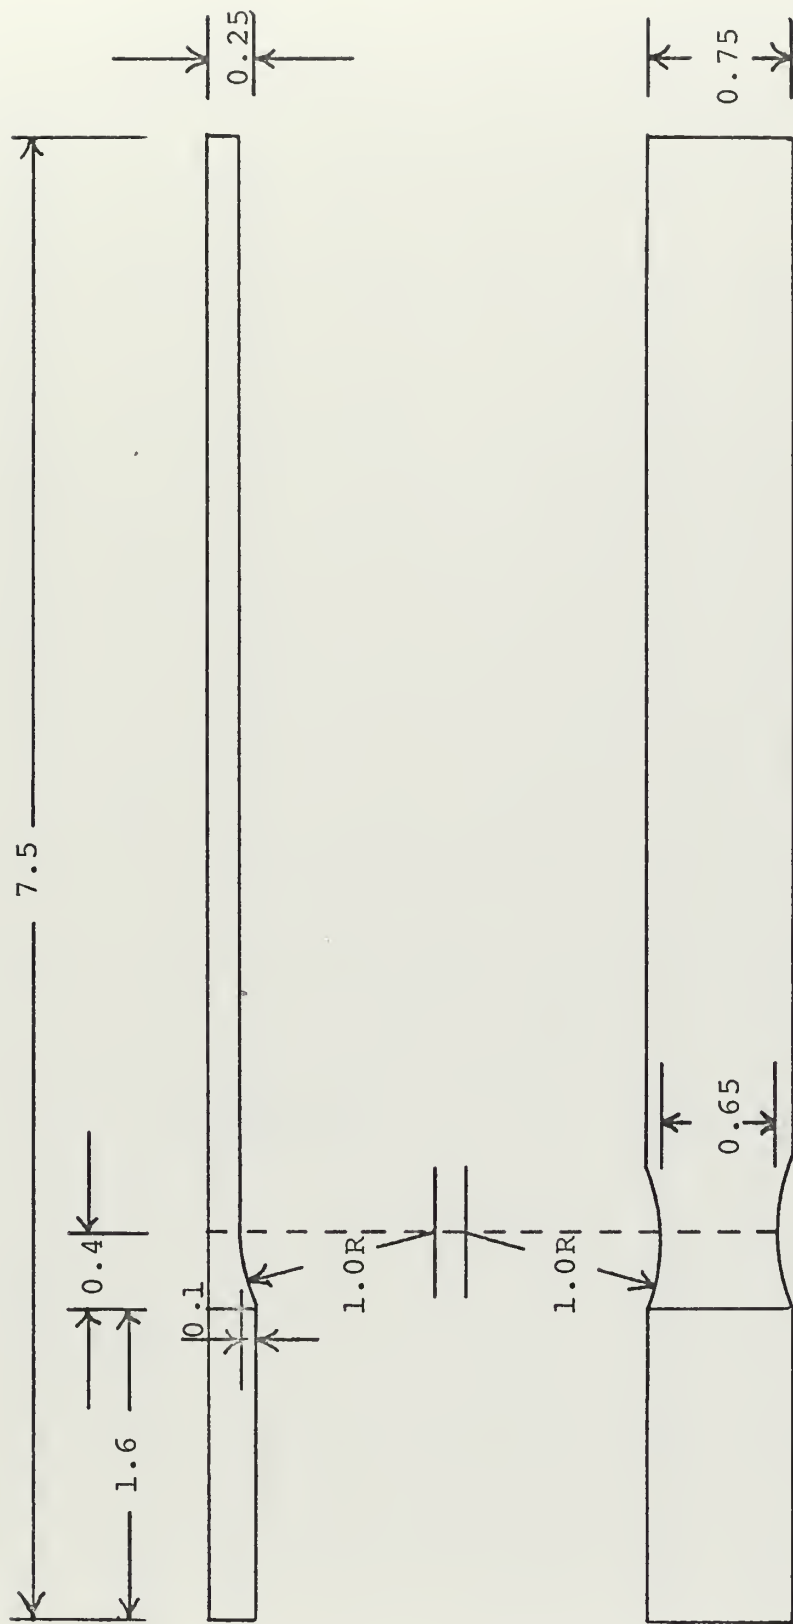
Figure 2. S/N Fatigue Specimen, Type 2

To eliminate this tendency to crack on the bottom surface, a series of modified specimens was tested. Specimen types 2 and 3 (Fig. 2 and Fig. 3) were tested. Type 2 had the stress raiser on the bottom eliminated completely, only the width of the specimen being reduced. However, the reduction in area was insufficient to make this reduced area the point of maximum strain. As a result the specimen cracked at the edge of the clamping block (Fig. 4). It was felt that any further increase in the depth of the side cuts would create excessive stress raisers in these areas. To avoid that possibility, specimen type 3 was tested. A stress raiser still exists on the bottom. The effect of this stress raiser did not appear to be sufficient to make the bottom surface the preferred area to crack. Further tests at various strain levels appear to have verified this belief.

The specimens used for these tests were specimen type 2 (Fig.2). In this case the stress raiser on the lower surface had been removed. The only stress raiser that existed in this specimen was on the sides. The initial data shows that the plot of ΔR vs. N closely follows the characteristic curves. However, as the number of cycles increased the slope of the ΔR vs. N began to decrease. At that time no reason could be observed for this change in the slope. During test #14 after 66,626 cycles the specimen physically parted at the clamping block. The same type of behavior was noted in both test 15 and 16. The stress raisers that were cut in the sides of the specimen were insufficient to make this the area of maximum

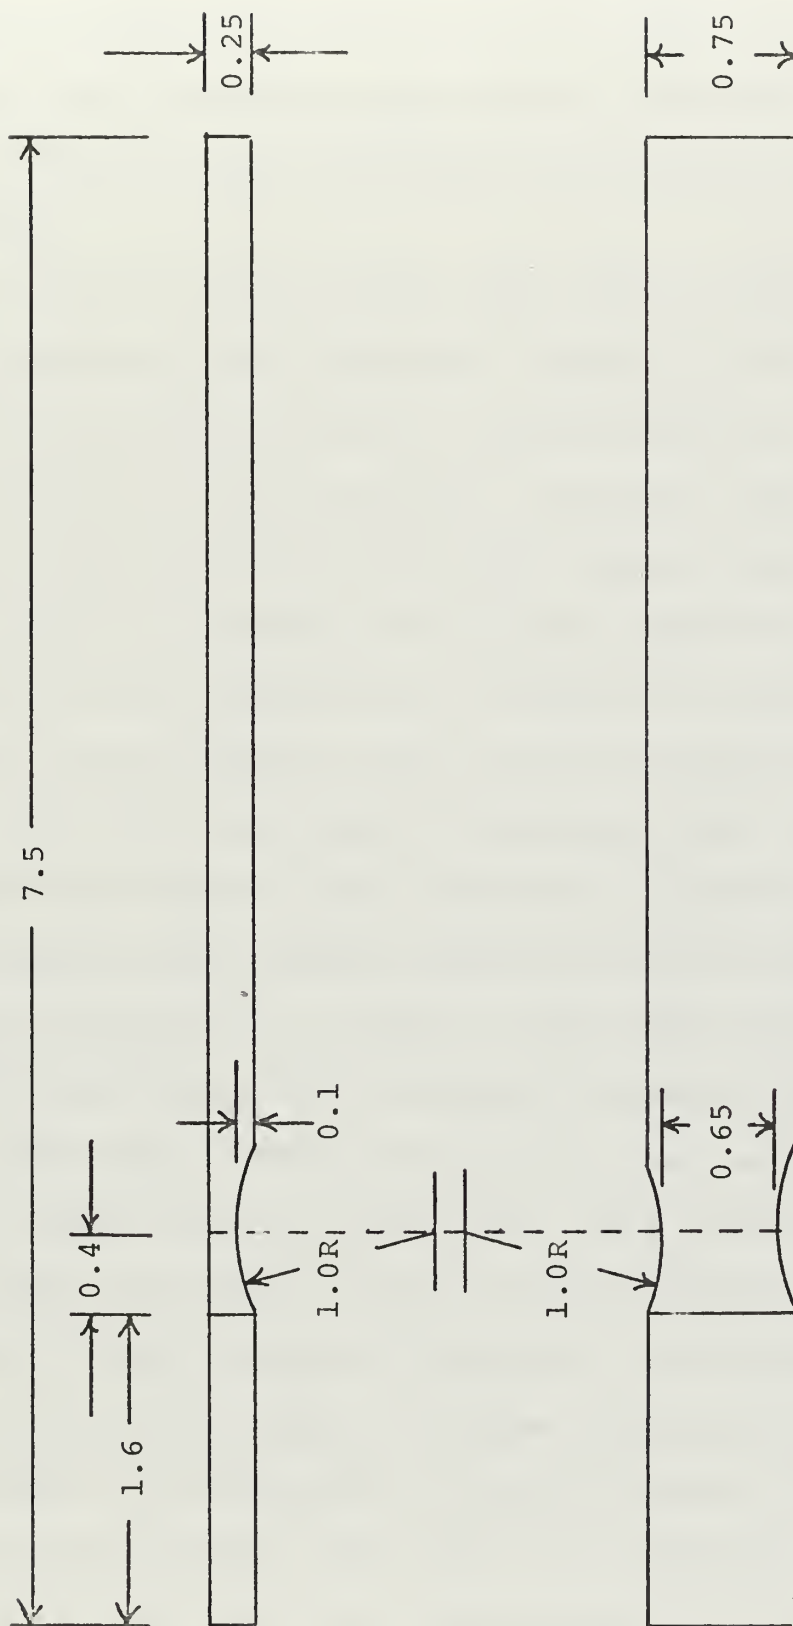
Figure 3. S/N Fatigue Specimen, Type 3

This was the first test conducted using a modified specimen. Specimen type 3 was used for this test with a strain level of $3101\mu\epsilon$ and a mean strain of $1081\mu\epsilon$. The first crack was observed after 11,012 cycles with a ΔR of 4.26 ohms. After 13,008 cycles with a ΔR of 4.37 ohms the first cracks were observed on the lower surface. The test was terminated after 20,996 cycles at a ΔR of 5.37 ohms. The major cracking in this specimen occurred on both the top and

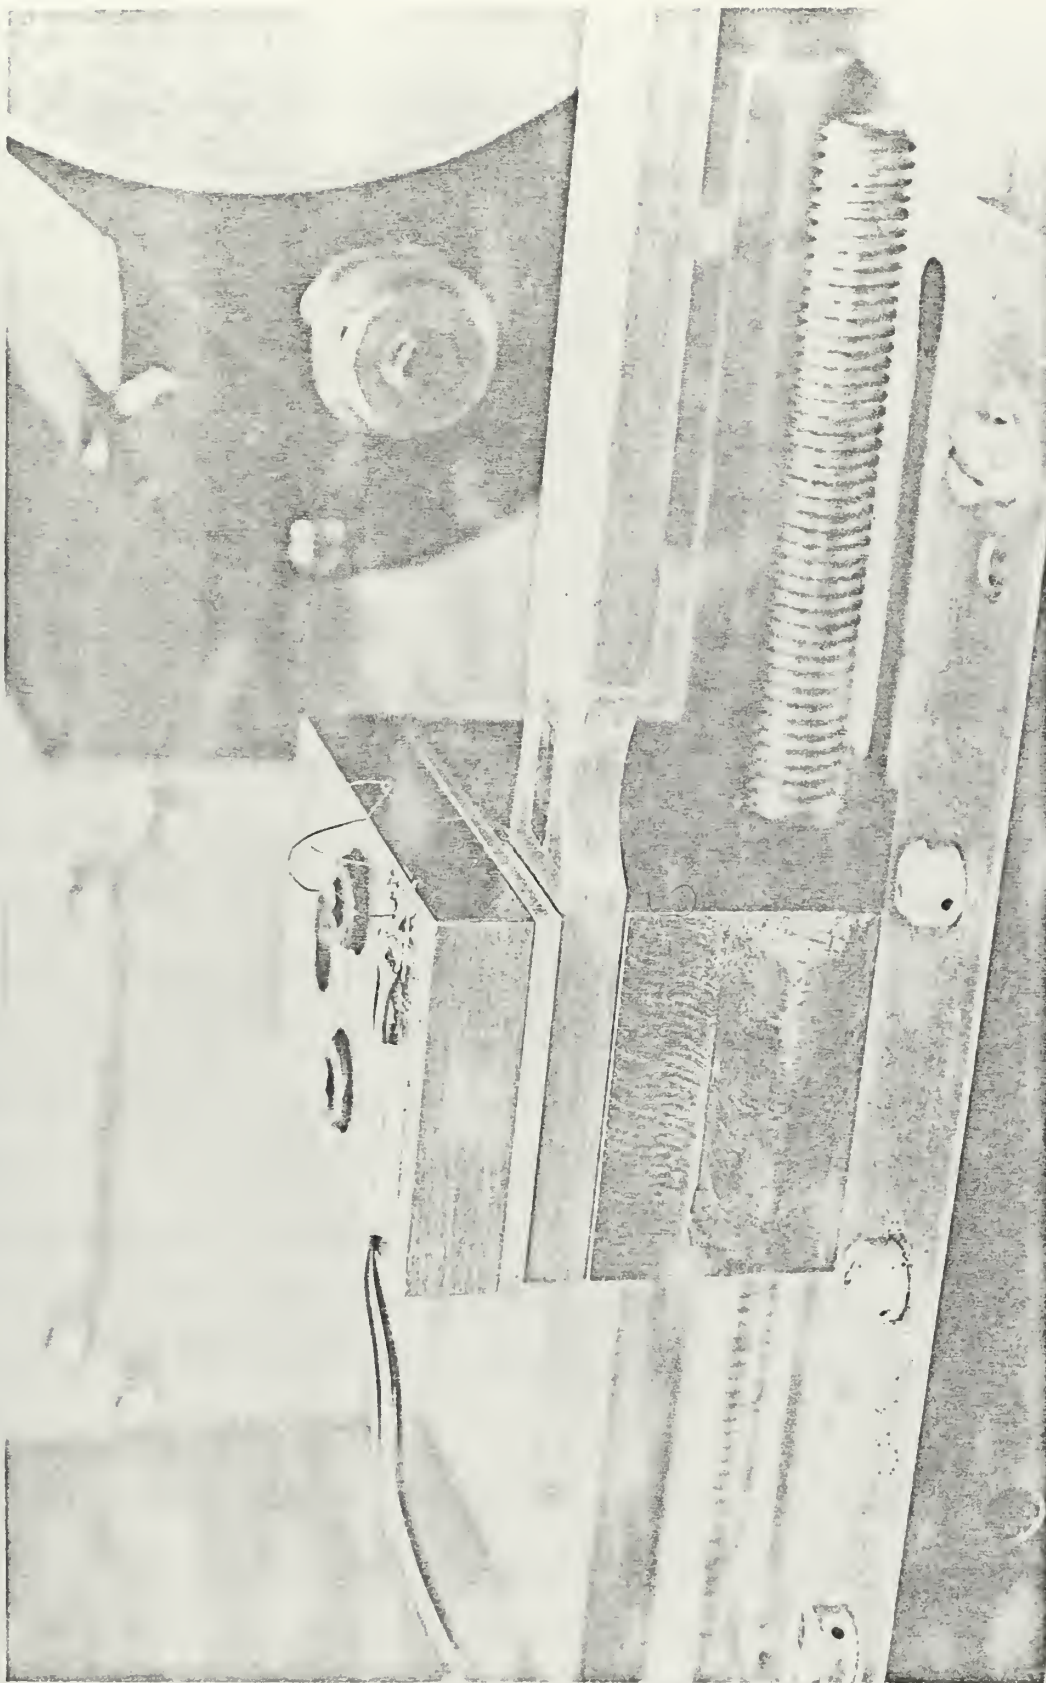
Figure 4. Test Specimen Mounted in Clamping Block

With the specimen properly mounted in the clamping block the gage leads were connected. The gage was connected to a terminal strip mounted on top of the clamping block. This method of connection was used to avoid any interference between the electrical leads and the flywheel at high strain

levels. A one inch piece of 134-AWP solid copper wire was used to increase the length of the gage leads. This was done to avoid contact between the leads and the clamping block. It also helped to eliminate the possibility of gage lead fatigue. Figure 4 is a photograph of the completed installation.

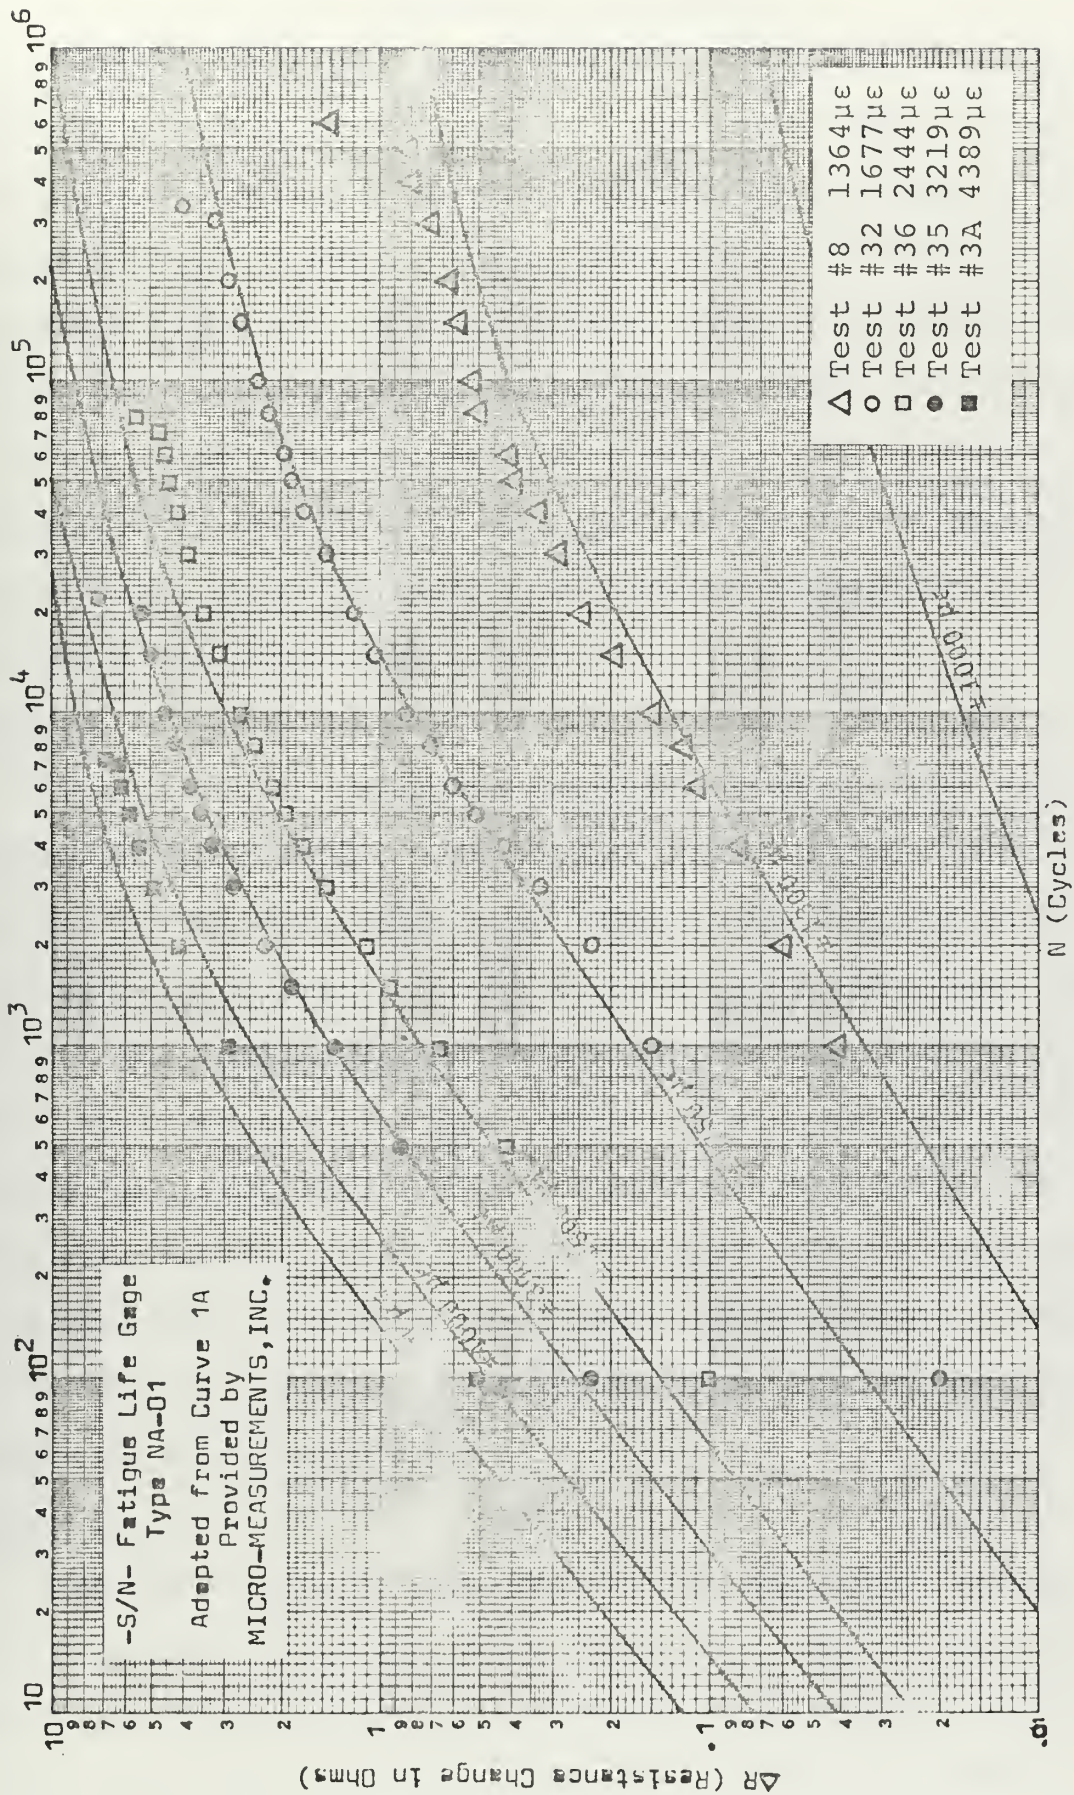
Figure 5 is a plot comparing several typical tests with an adaption of the manufacturer's characteristic curves for the type NA-01 gage. The data plotted is the results of tests 8,32,36,35 and 3A. These tests were selected because they represent various strain levels between $1364\mu\epsilon$ and $4389\mu\epsilon$. A comparison of the data with the curves shows that at all strain levels plotted, the gage registers resistance changes that agree closely with expectations.

Figure 5. Performance Curve Showing Results of Selected Tests

A complete record of all tests is included in Appendix D. A plot of any of this data will result in curves that closely correspond to the curves in Figure 5. (The exception to this can be noted on tests 14 through 16 when specimen type 2 was used.) A discussion of the various tests is included in Section IV.

Figure 5 is a plot comparing data collected with the manufacturer's characteristic curves. It can be observed that the gage reacts in a predictable manner when bonded to 70-30 copper-nickel. However, these plots are tests that were continued until the gage had failed. The ΔR at which the first cracks were observed varied between 0.97 and 3.27 ohms.

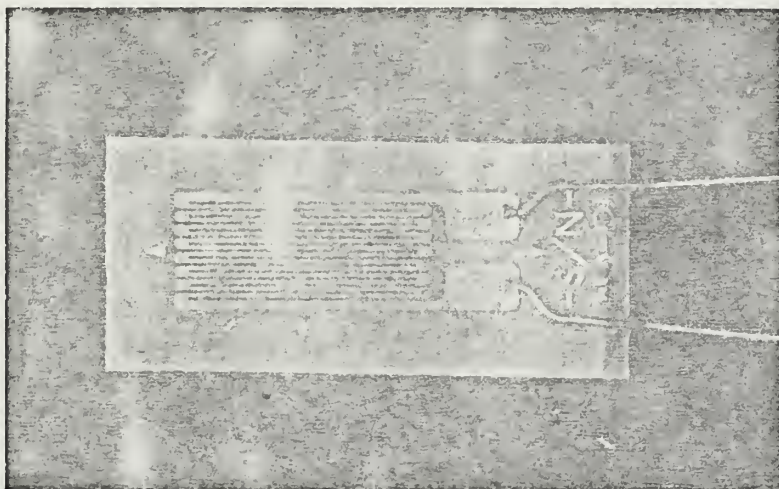
The S/N Fatigue Life Gage has the general appearance of a common foil strain gage (Figure 6). It is constructed of a specially treated constantan (approximately 55% copper, 45% nickel) foil grid encapsulated in a glass-fiber/epoxy laminate. The gage is available in various sizes with either solder turrets or integral leads. Application of the gage is made using standard strain gage adhesives and techniques (Ref. 1).

Figure 6 - S/N Fatigue Life Gage

The gages used were provided by Micro-Measurements, Inc., Romulus Michigan. They were the FWA-01 series with a constantan grid and a glass-fiber/epoxy laminate. The initial resistance of the gages was $100.0\Omega \pm 0.2\%$ with a gage factor of 2.04. All gages used were from lots ZD-A12AP39 or ZD-A12AP41 (Figure 6).

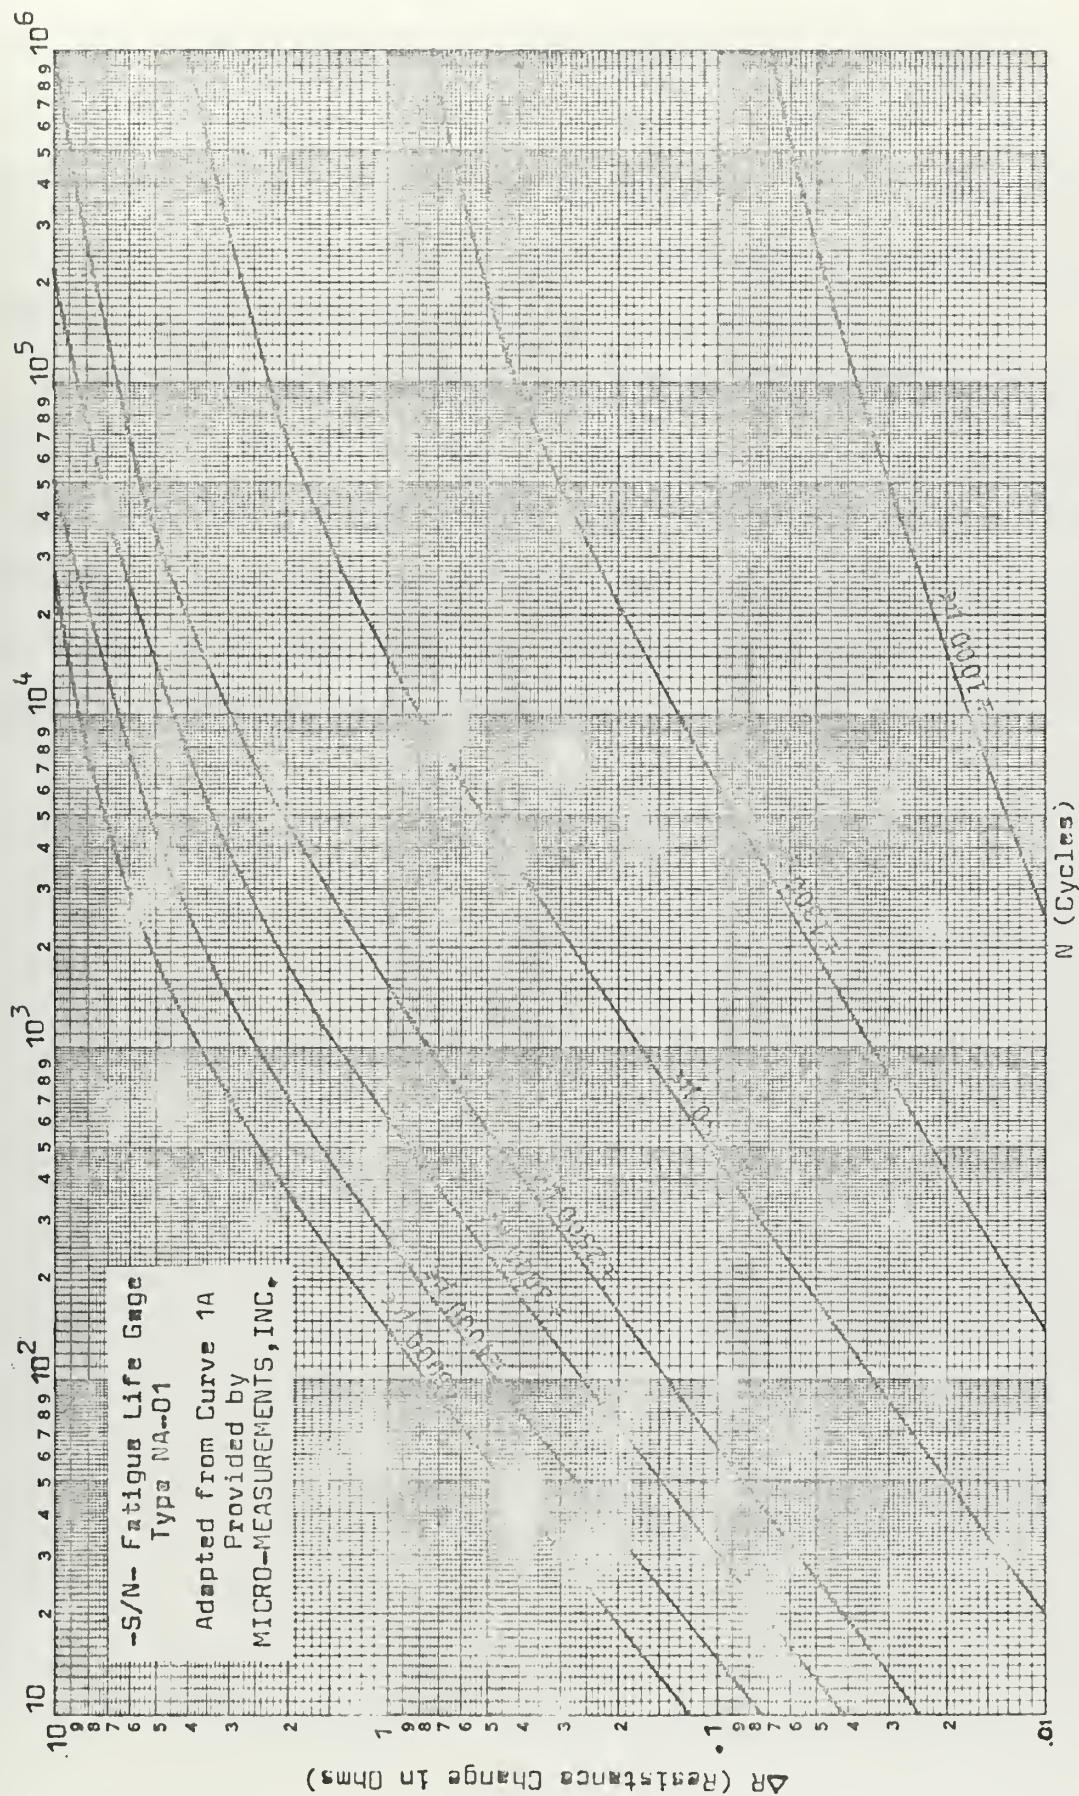
The resistance change of the sensor is a result of cumulative fatigue damage caused by varying strains. Figure 7 is a plot showing ΔR (Resistance change) vs. N (Number of cycles) at various strain levels. The curves are a result of cycling about a zero mean strain. Experiments have shown, however,

Figure 7. Performance Curves of Type NA-01 Fatigue Life Gage

that the same curves also correspond fairly closely to cycling about a non-zero mean strain providing the total strain amplitude ($2\epsilon_R$) is not too small (Ref. 3). Triebes (Ref. 7) concluded that the performance of the gage is virtually unaffected by the application of a mean load.

Since the gage response is basically independent of the mean strain, the ΔR caused by tension-tension or compression-compression at a given strain level is the same as for reversed bending. It is also noted that the curves are a plot of ΔR vs. N and as a result do not depend on the nature of the material to which they are bonded.

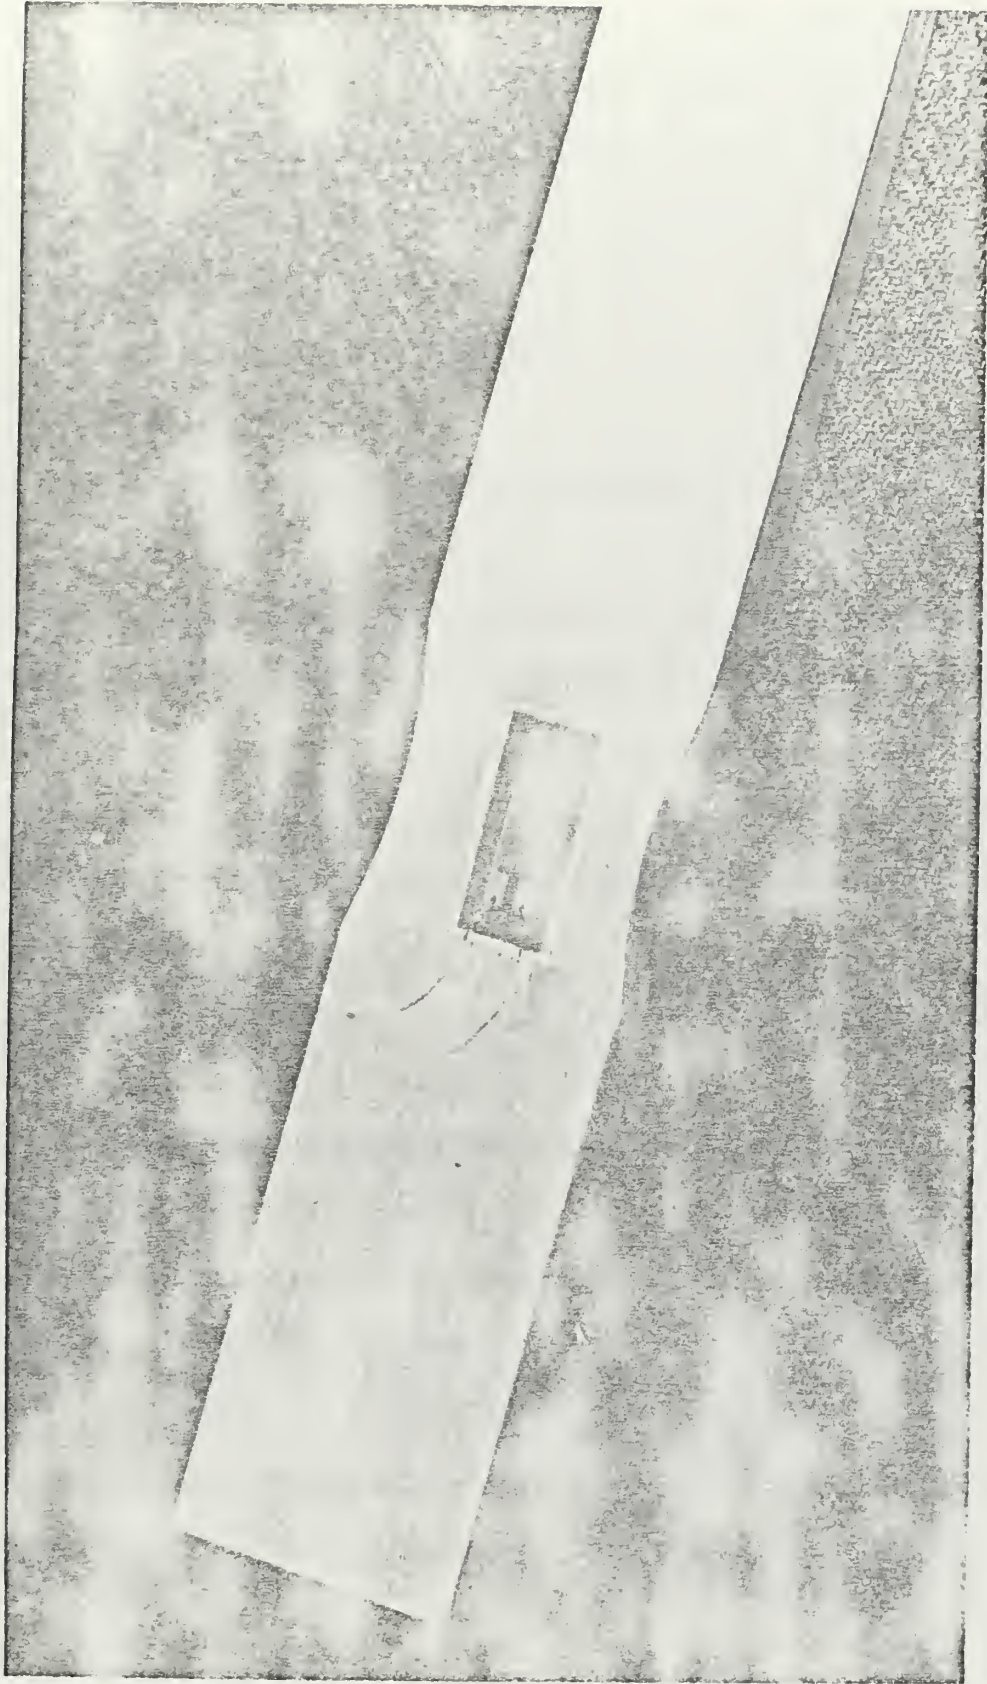
Figure 8. Mounted Gage Ready for Testing

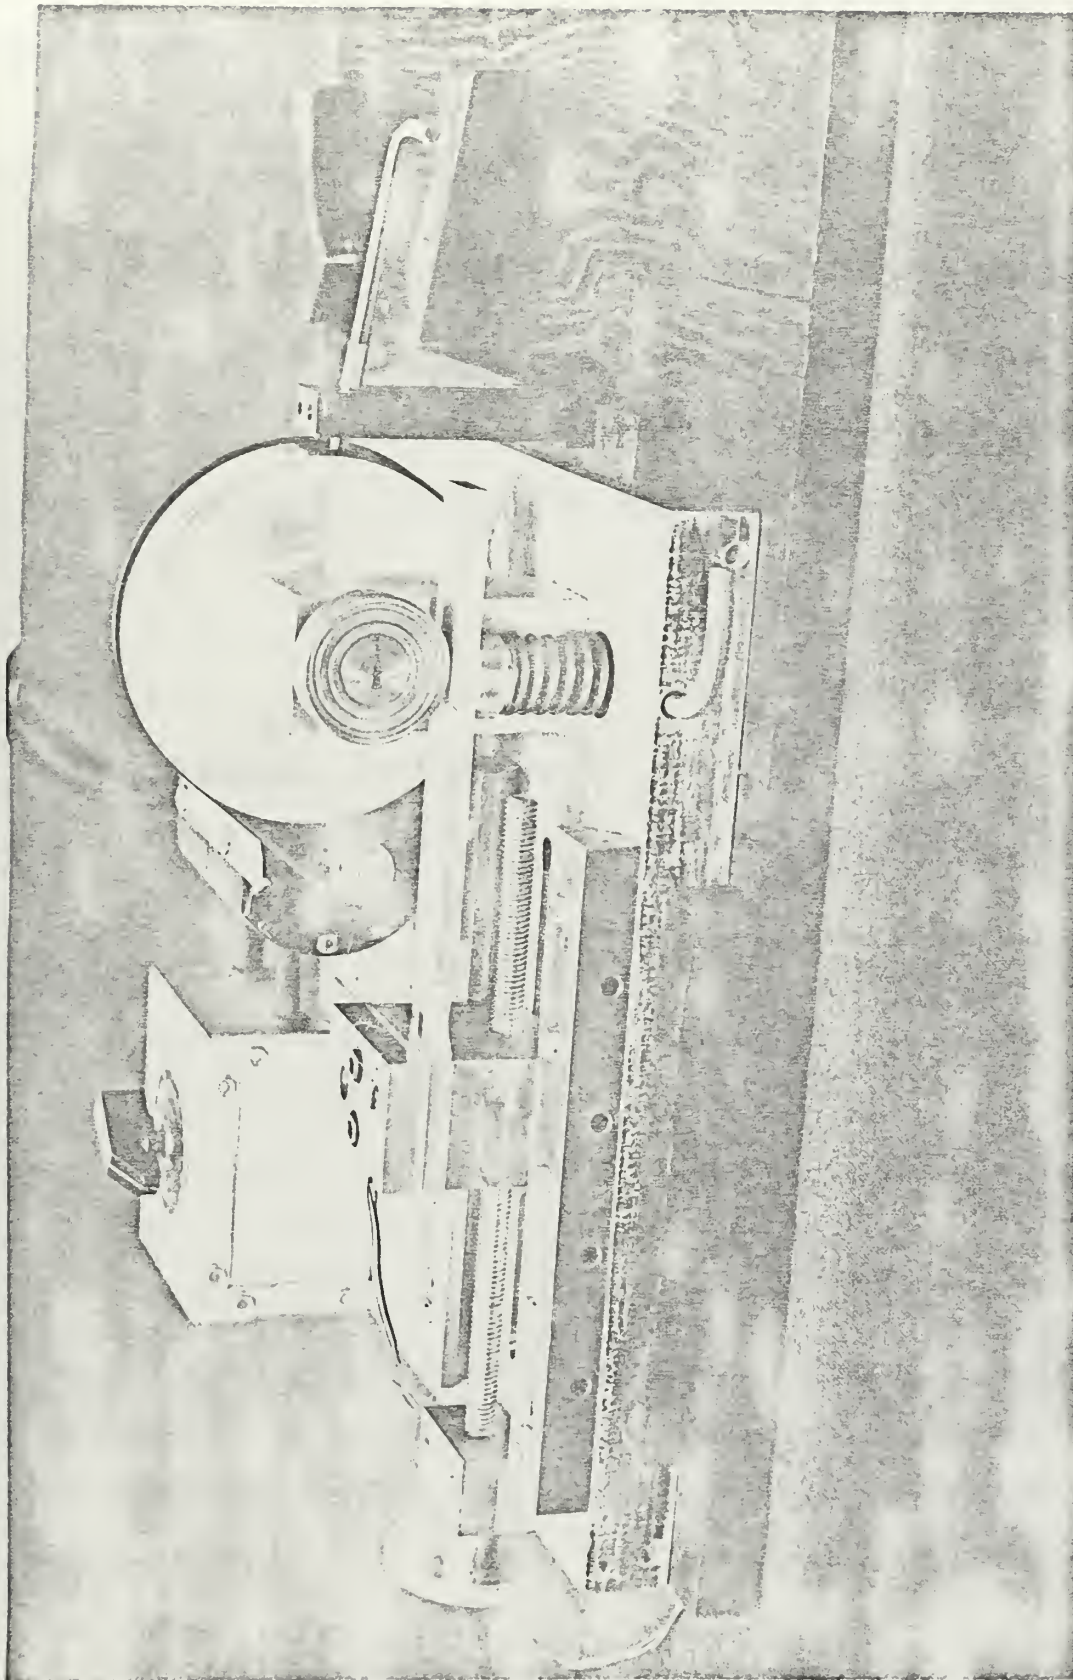
Figure 9. Test Set Up Showing Modifications to Fatigue Machine

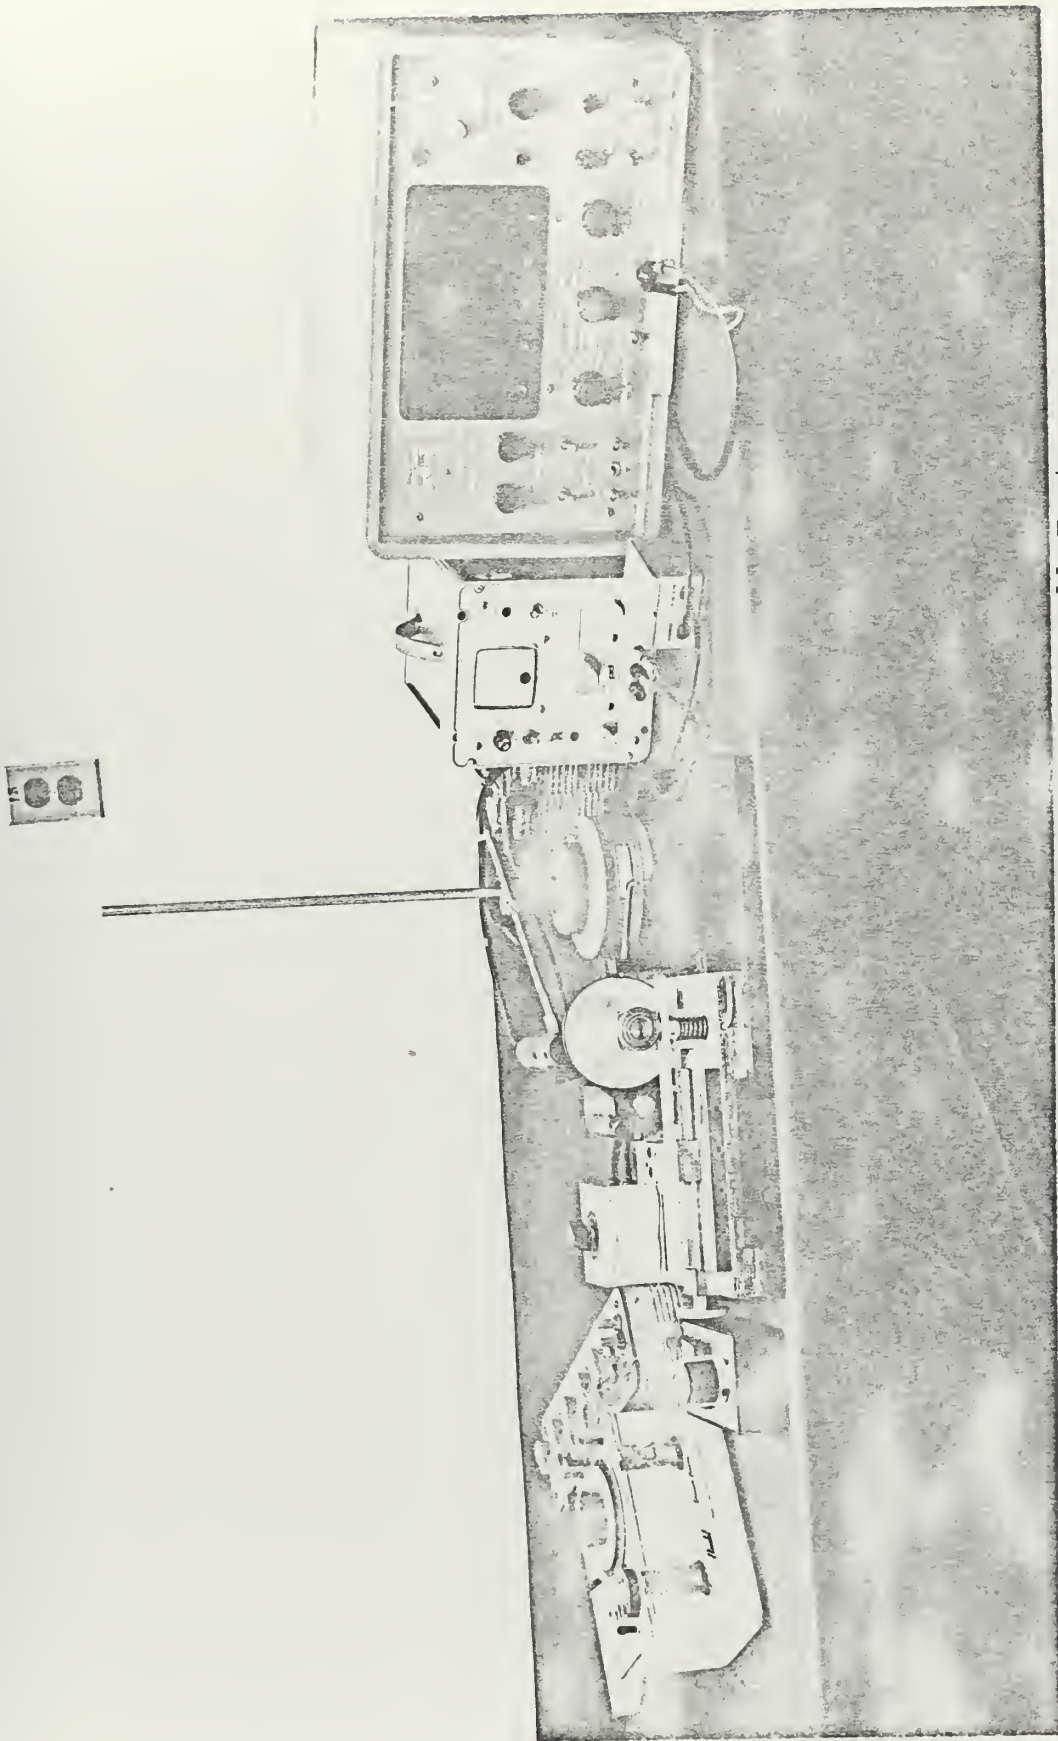
A complete description of items one through seven can be found in Reference 4. Figure 10 is a photograph of the apparatus.

Figure 10. Test Apparatus Used for All Tests
